Can Cooling a Cylinder with Dry Ice Embrittle It?

Aug 2022

Chemically Speaking LLC

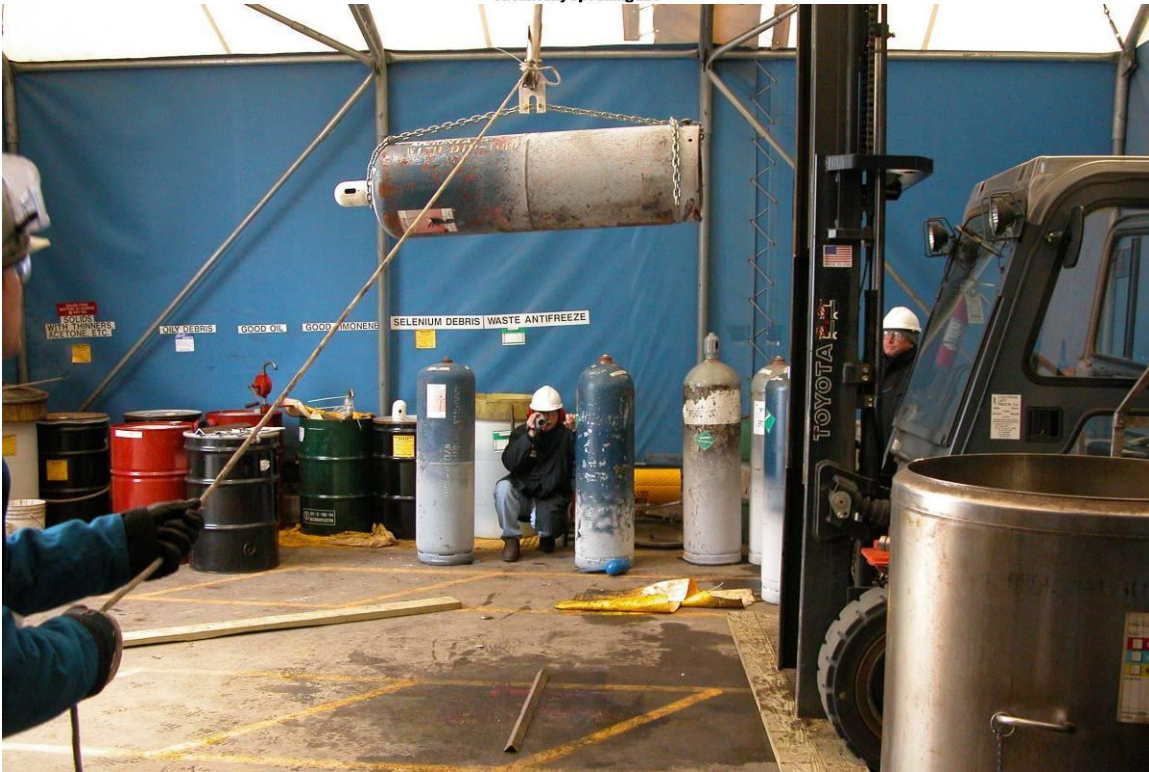
9. Test #9 – Test #8 was repeated, but the cylinder was dropped on the side 180° away from the side impacted in Test #8. A deep dent (Figure 9) was found on the cylinder sidewall about 3 inches (7.5 cm) above the weld. There was also some minor secondary denting that occurred when the cylinder bounced after initial impact.
