Solkatronic Chemicals Silane CG-4 PRD Incidents

Date: May 14, 2009

To: CGA G-13 Task Force

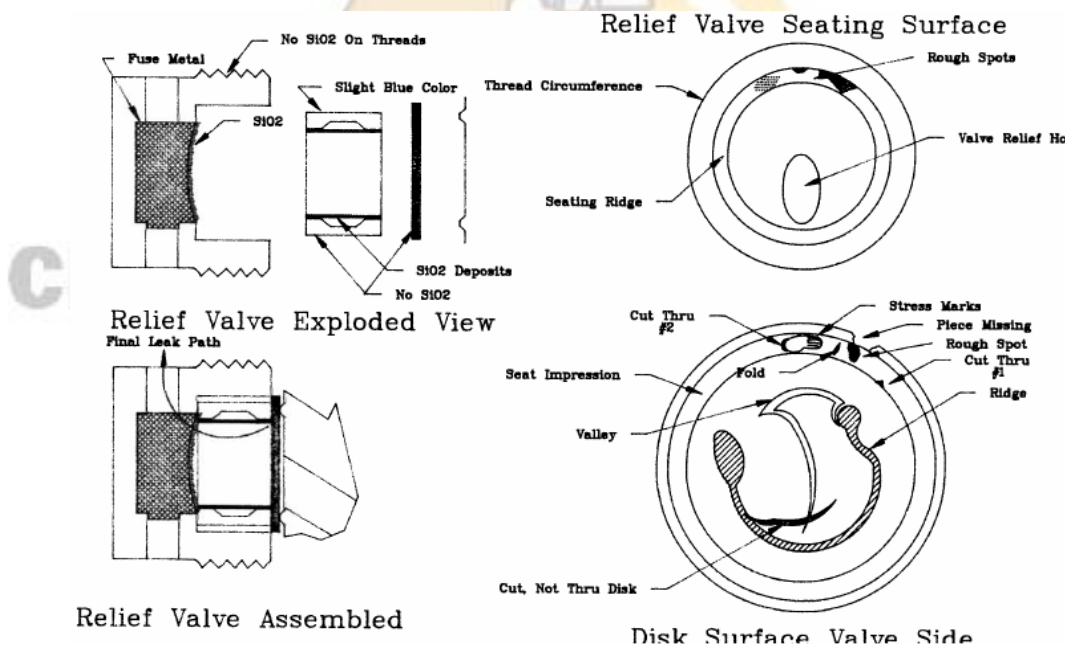
On April 17, 1989 a pure silane cylinder at a customer site in Phoenix, AZ started to leak at the PRD when the valve shrink wrap was removed. This ignited, producing a small flame. The site ER team quickly vented and inerted the cylinder. This was a new cylinder and valve that was filled on Jan 13, 1989. The valve was a pneumatic valve which was of a new design. It had a unique PRD assembly which compressed the metal rupture disk against a polished bead (seating ridge) machined into the valve body.

This valve was taken apart at the valve manufacturer and visually examined. It was concluded by the investigation team that the polished bead was poorly polished and inspected. As the rupture disk was being compressed against the valve body, the disk rotated against this rough surface causing 2 tears. The fuse metal held back any gas leakage for a number of months. It started to cold flow and slowly pushed the fuse metal out of the PRD collar and then continued extruding at the vent holes until it started to leak.

Other valves from this batch were removed from other filled silane cylinders and examined, none had the same bead damage. The valve manufacturer modified his design and inspection procedures and there were no further PRD problems. This valve design is no longer being made.

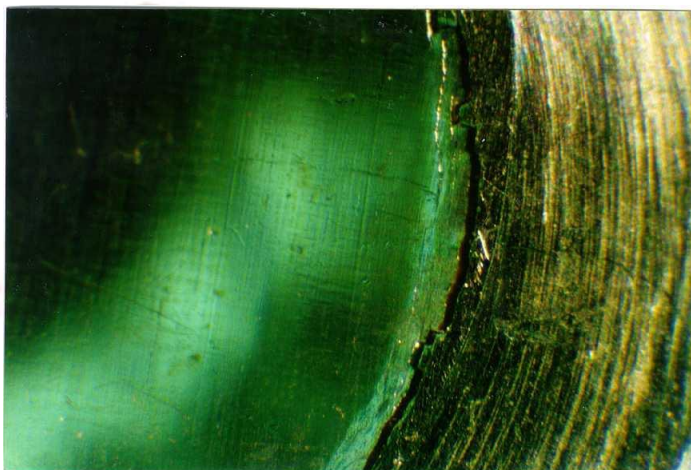
24 new cylinders and valves were filled on August 1991 with a 20% silane/hydrogen mixture. 5 were never used and returned by the customer to Morrisville, PA where they were stored on an open dock. On July 6, 1998 one of these cylinders was reported to be smoking at the cylinder cap. This quickly developed a 6" flame at the cylinder cap vent hole. As the ER team approached the cylinder 10 minutes later, the PRD fully activated, releasing the contents of the cylinder in <2 minutes. The flames impinged on 2 adjacent cylinders and the dock roof. It did not cause any other cylinders to leak. The PRD was removed from the cylinder and a visual inspection revealed that the rupture disk had fully ruptured

This was a manual valve was made by a different valve manufacturer. It had a CG-4 PRD which consisted of a Platinum clad copper rupture disk and 165°F fuse metal. The other 4 cylinders were immediately vented and the valves taken apart for visual inspection. One cylinder was found to be empty, a visual inspection revealed that the rupture disk was fully cracked through (see picture). Other than extruded fuse metal, there was no other visual

evidence of a leak, e.g. SiO₂, fire damage. A second cylinder also had a crack through the rupture disk and the fuse metal was extruded but it had not started to leak. The remaining 2 had cracks only in the platinum layer.

Based on our findings, we initiated a worldwide recall for all cylinders with platinum clad copper CG4 devices containing metal hydride gases or as a hydrogen mixture. We also immediately alerted the CGA community to the problem by filing an incident report and asked to make a last minute presentation at the 1998 CGA Specialty Gas Safety Seminar about the incident and findings

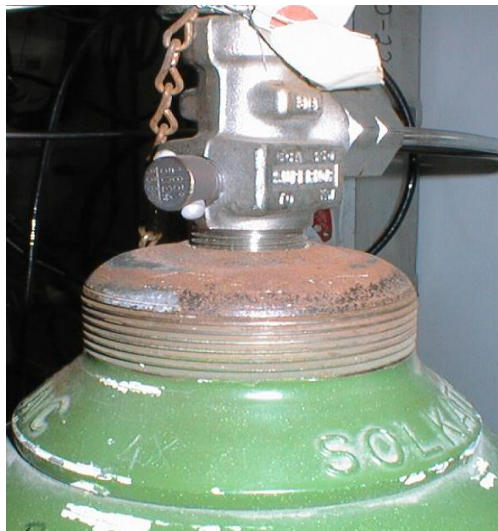
3 Diborane mixture leaks at customer sites which triggered emergency responses in 1993 & 1995 were all examined by the valve manufacturer. All had extruded fuse metal (see picture) and fully cracked rupture disks. The engineering report suggested that the cause of the cracks was due to fatigue.

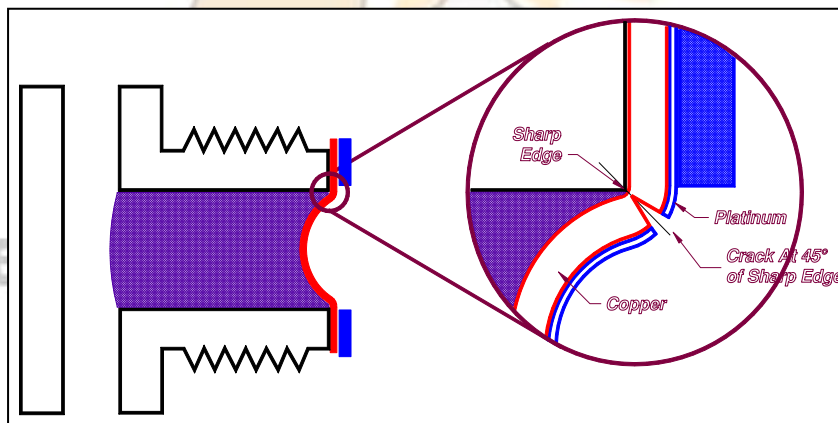
Based on the tests, analysis and discussions with materials and valve experts, it is believed that the leaks have occurred due to an unusual combination of factors, all of which had to occur at the same time for the leaks to develop. In outdoor storage or during shipment in a closed cargo container, a cylinder can experience significant temperature changes from night to day of $>60^{\circ}\text{F}$. Testing has shown that cylinder skin temperatures in the summer if exposed directly to the sun can reach 150°F . This in turn will cause significant pressure swings in a full cylinder. In the extreme case of a pure Silane filled to the industry fill density of 0.313 kg/l , the pressure swing can be approximately 1000 psig. This change in pressure flexes the rupture disk against the sharp edge of the PRD. (see figure)

It has been theorized that craking is occurring as a result of hydrogen migrating into the platinum layer. One company during their investigation found evidence of embrittlement of the Pt-Cu alloy by hydrogen. They theorize that the platinum was cracking the metal hydride gas or hydrogen to form atomic hydrogen which diffuses thru the platinum layer and embrittles the alloy (Pt-Cu) in the middle of the disk.

With the repeated flexing that can occur over a period of a few years, the disk will start to crack. Based on discussions with a valve expert, cracks if they are to initiate will occur immediately above the discontinuity caused by the sharp edge of the housing. SEM scans indicate that the crack was at a 45° angle to the initiation point, which is indicative of tension failure around a sharp edge. The bond of the Platinum to the Copper is so strong that the crack will continue to propagate into the Copper bottom layer with time.
