Diborane

Diborane Cylinders

Diborane Incidents

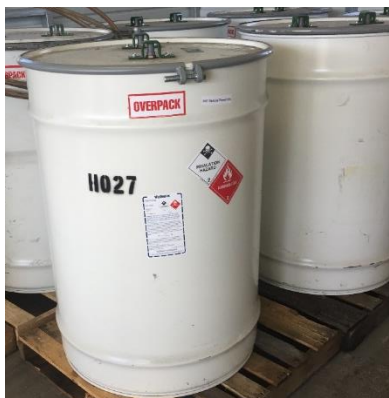
Fig 2: Insulated Shipping Drum

Due to the decomposition, DOT requires a cylinder filled with diborane or its mixture to limit the fill amount assuming byproduct hydrogen if it fully decomposed will not exceed the working pressure of the cylinder. (49CFR§173.302a Additional requirements for shipment of nonliquefied (permanent) compressed gases in specification cylinders. (d) Diborane and diborane mixtures). This severely limits the amount of pure diborane that can be shipped to 0.070 kg/l (2707 psia). To increase this amount (0.280 kg/l (10,832 psia H₂), pure diborane is shipped to gas suppliers in the US in an insulated container packed with dry ice under a DOT Special Permit 970 and it must reach the destination in 10 days. otherwise the supplier would have to conduct an immediate search for the cylinder since the amount of diborane in the cylinder if fully decomposed would over pressurize the cylinder with hydrogen.

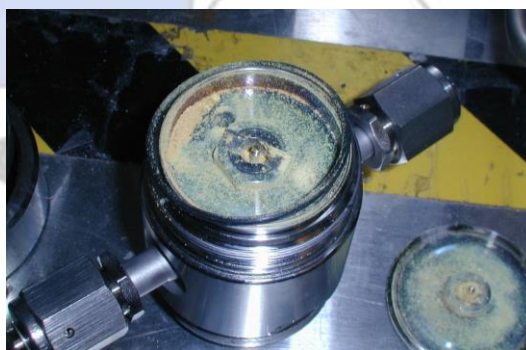
Fig. 3: Regulator with Solids

Diborane will also readily react with any moisture or oxygen in the piping system, forming solids which can plug the system or cause regulators to no longer control. These solids can be toxic and flammable, Decaborane 14.

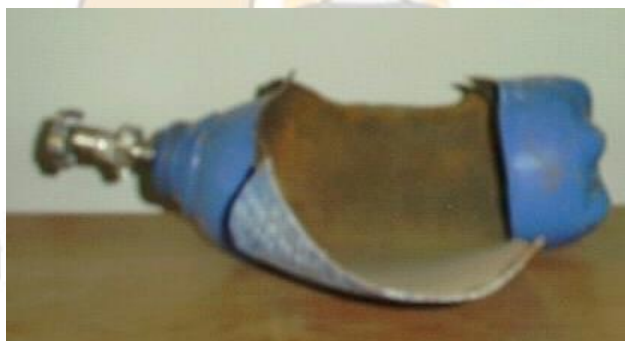
Fig 4: Cylinder Ruptured Minutes after Sodium Hydroxide Addition

10 l stainless steel collector, 2130 psig working pressure that was used to condense B_2H_6 from 30% mixture cylinders. After 15 cycles it was being cleaned of residue. NaOH sol was added and valve closed. 2-3 sec later cyl ruptured. One operator was burned on face and hair. Hearing loss. Burning residue shredded pants of second operator and burned his leg. A 11" x 8" x 1/4" fragment flew 500-600 yards and damaged a car.

Numerous cylinder cleaning incidents and as a result CGA published P-73 Safety Alert, Hazards Associated with the Decontamination, Disposal, or Requalification of Cylinders in Diborane, Diborane Mixtures, and Pentaborane Service

These cylinders are now cleaned using special procedures and systems or by waste disposal companies.

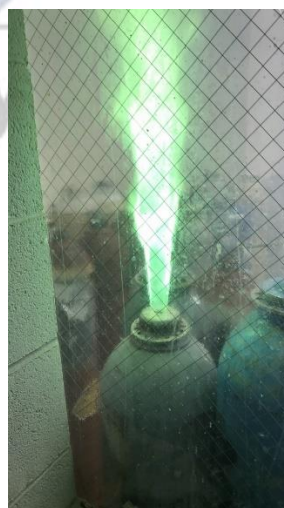
Fig. 6: Reaction of Boranes During Cleaning

Explosion during disposal of 20 lb Pentaborane cylinder when a Sodium Hydroxide/Methanol solution is injected into the cylinder. The explosion ruptured the 200 gallon 200 psig rated containment vessel.

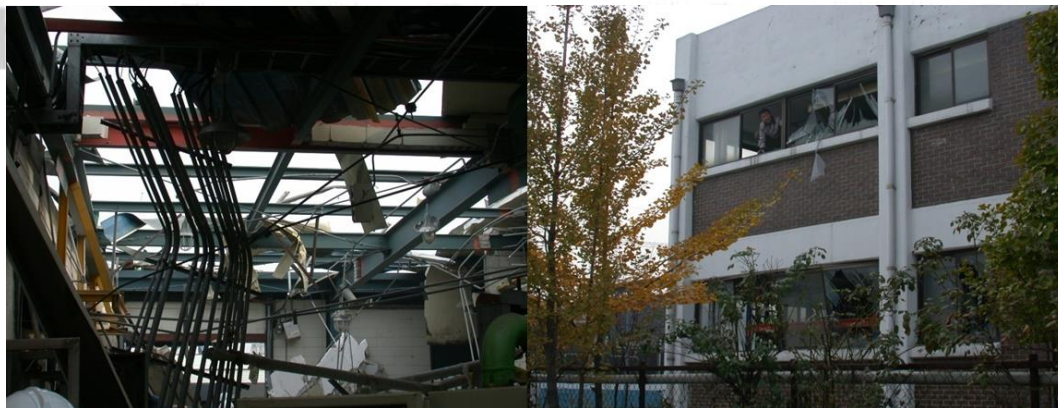
Figs. 7 & 8: Damaged Ceiling and Windows Blown Out 100 ft Away

On a cylinder roller a pure diborane cylinder opened releasing diborane. Since it is lighter than air it accumulated in the ceiling. The diborane also hydrolyzes to form 3 moles of hydrogen. This ignited and the explosion blew out the walls in the room and roof. The blast blew out windows 100 ft away.

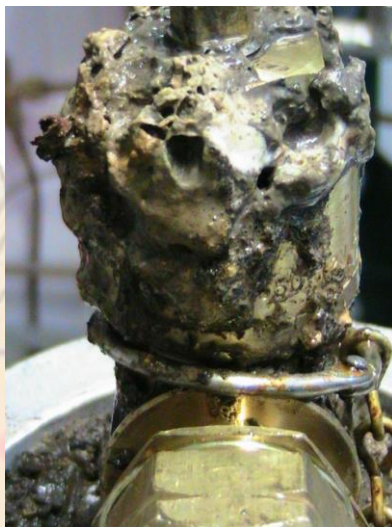
Fig 9: Melted Cylinder valve Handwheel

During transfill of pure diborane a leak and fire occurred at the cylinder valve outlet connection. The fire triggered the sprinkler head in the hood but the diborane continued burning for 30 minutes melting the valve handwheel. Sprinkler cooled the other cylinders in the hood. The cylinder lost 3 kgs of diborane a leak rate of 87.7 liters/min!

No injuries and damage only to the cylinder valve.

1. The leak was caused by the operator not cleaning the outlet connection of solid borane deposits. While it passed a leak test, full pressurization with loosened the solids and the fire then loosened the connection further.
2. Like a silane leak and fire, the sprinkler water did not extinguish the diborane fire.
3. The melted handwheel and large fire prevented the operator from closing the valve. There have been other incidents like this with pyrophoric gases. In one case the only option was to tighten the outlet connection. This is why the use of a pneumatic cylinder valve is a Best Practice.

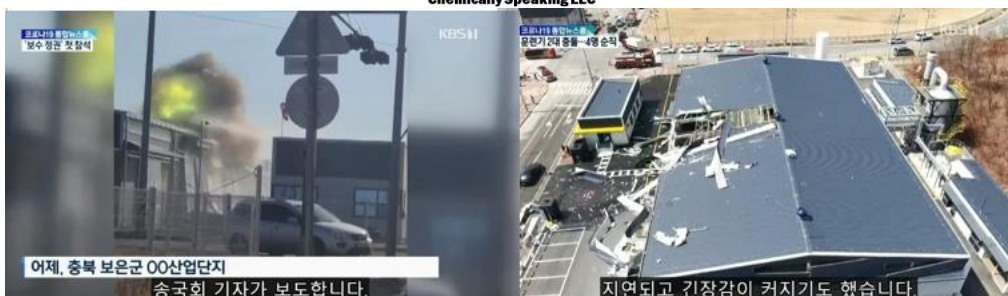
Figs. 10 & 11 : Diborane explosion Korea (KBS News)

Korean gas supplier had a gas manufacturer had a diborane leak on April 1, 2022 in their cylinder storage room. The fire caused 4 aluminum cylinders to rupture over a period of 30 minutes.
