## Gollob Silane Incident

### Gollob Silane Incident, March 17, 1988

The tragic silane cylinder explosion at Gollob Analytical Services in Berkeley Heights, NJ killed 3 individuals, severely injured one and caused significant property damage. It had a profound impact worldwide on the compressed gas and the Semiconductor industries.

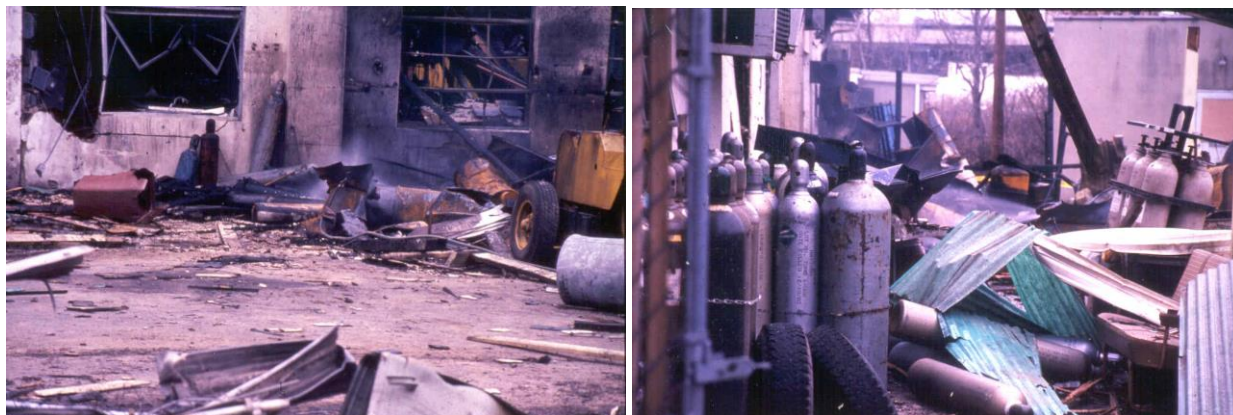
Figs. 2 and 3: Damage to Building and Room

The explosion blew apart the one story building causing considerable damage. Numerous cylinders were thrown around and there was a fire in the building. Dennis Feeney, Lou Molinini and James Cavellas who were outside venting the cylinder died instantly. It appeared that they were trying to escape as the bodies were found 15-60' from each other.

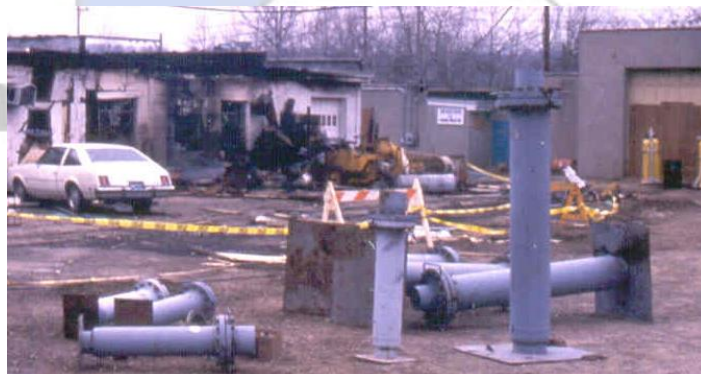
A phosphine mixture cylinder was leaking and on fire for almost a week. Since it was next to an arsine cylinder there was concern that it would cause it to leak as well. The officials extended the evacuation zone to ½ mile. Approx 1500 people including a nursing home (120 residents) were evacuated from Thursday to Sunday as the DEP and private contractors worked to stabilize and remove the leaking or damaged cylinders. There was concern that the phosphine cylinder would leak for a few more weeks so the waste disposal company placed the phosphine cylinder onto a metal plate and surrounded it with sandbags. They then put a shaped charge on it and blew it up. A number of arsine cylinders were leaking. Seven cylinders were placed in cylinder overpacks and removed.

Fig. 4: Cylinder Overpacks
