Anhydrous Hydrogen Chloride

Hydrogen Chloride is a high pressure liquefied gas, toxic and corrosive acid

Hydrogen chloride is used in many applications. It has a high vapor pressure and is extremely soluble in water. It is extremely corrosive when hydrolyzed with the moisture in the air to form hydrochloric acid.

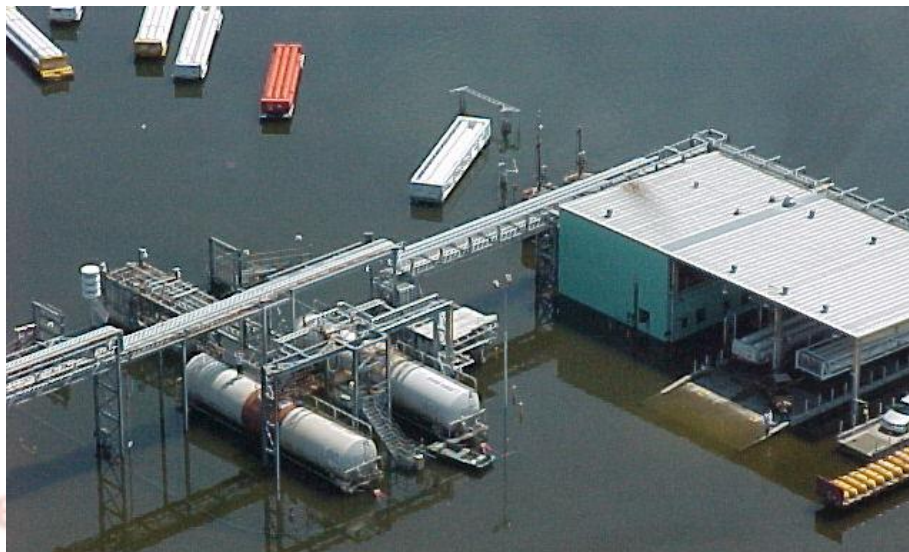
Fig. 3: HCl Railcars In Flood

During Katrina (2005) this was not possible at a gas supplier filling facility in New Orleans, LA. Due to flooding electric power was lost for many weeks. This allowed the vapor pressure to build to unsafe levels over many days. The typical pressure relief device has a metal rupture disk that blew at 450 psig into a spring loaded relief valve which reset at 275 psig.

Periodically workers would row out to the railcars and vent some HCl gas directly into the flood waters to cool the HCl in order to drop the pressure to prevent the pressure relief device from activating and venting the gas into the atmosphere.

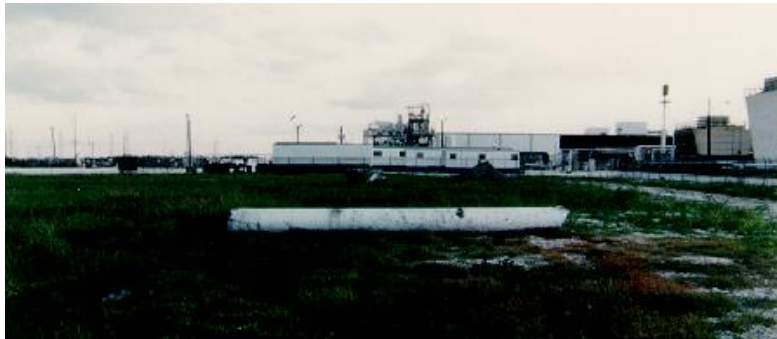
A returned tube trailer was refilled with HCl. The practice was to weigh the tube trailer to determine the amount of residue. This was assumed to be distributed evenly throughout the 8 tubes. It was then filled with cold HCl from a refrigerated railcar. As the HCl warmed up it expanded and the liquid filled a tube causing it to rupture the next morning. No injuries

Fig. 11: Ruptured Tube Flew Over 800 ft

Investigation determined that a tube was contaminated with cotton oil (1650 lbs) at the user site. It was filled with 2,600 lbs of HCl until it stopped flowing. It ruptured at an estimated pressure of 7000 psig, (due to the BLEVE) rapidly expanding liquefied gas tearing the tube into pieces. The tube was torn into two major pieces. The largest section consisting of ~80% of the tube ripped through the bulk head of ½" steel and landed 837 feet away. Trailers are now no longer filled with any residue. They must all be emptied before fill

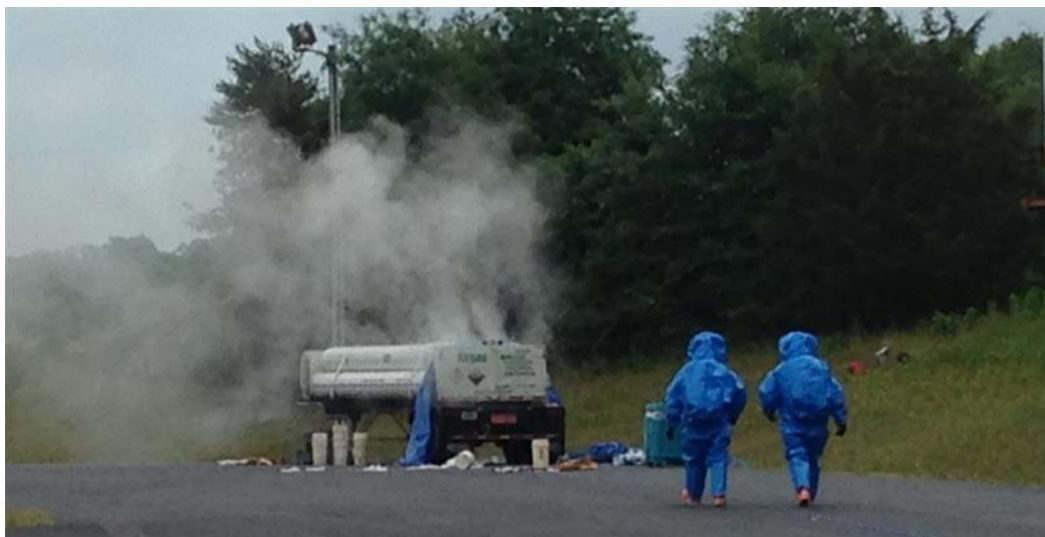
Leaking PRD noted by a driver on Route 85. ER team packed tube with dry ice to cool
Decision to cold coil transfer into an “empty” trailer. Empty trailer from Texas drove 20 hours to act as a reservoir for cascading the HCl. Dry ice on the tube surface was used to enhance the transfer.

Fig. 13: Leaking Tube Trailer
