Overview of Silane Incidents

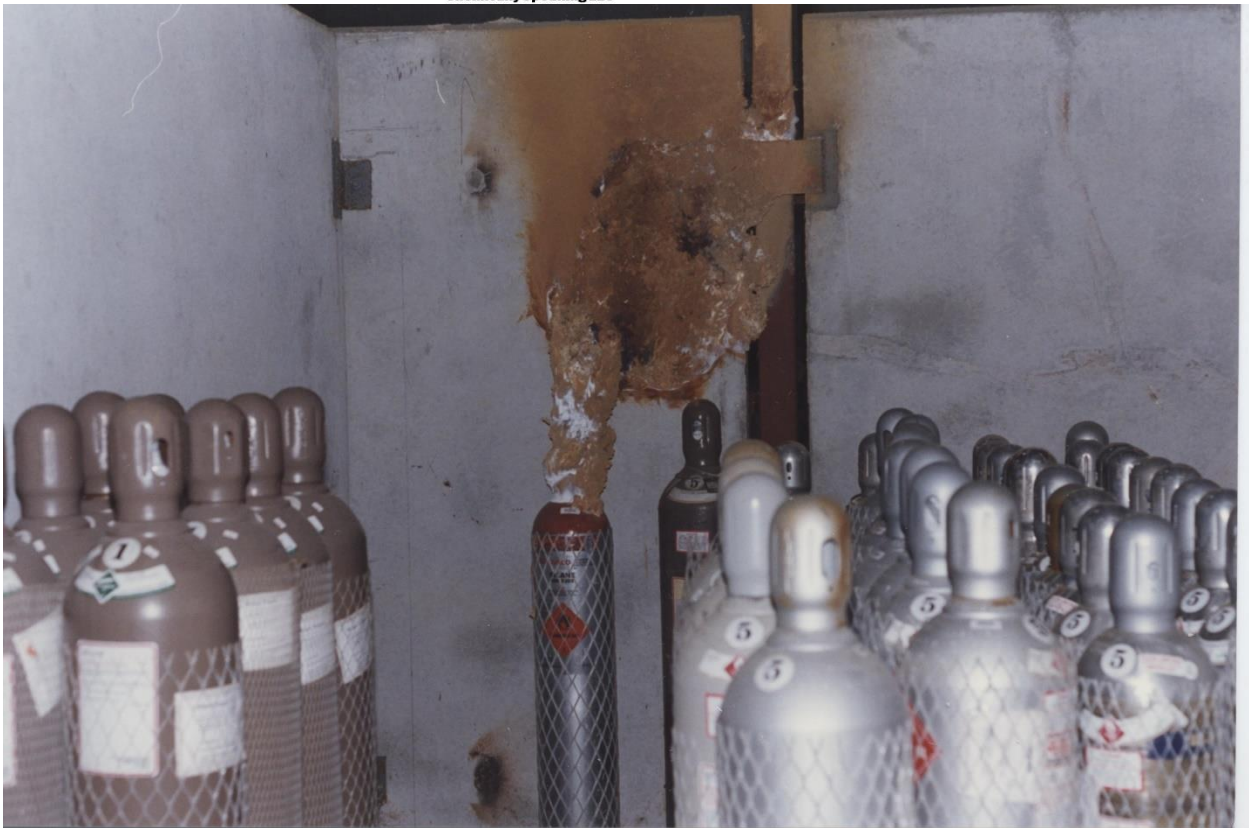
Pressure relief devices (PRD) have been one of the leading causes of silane incidents. These have caused considerable property damage but only minor injuries.

Since a CG-4 combination (metal rupture disk and fuse metal) device is used, a defect or improperly assembled PRD may not be readily apparent. If the rupture disk is compromised or loose the fuse metal will hold back the silane pressure for a period of time. At pressures above 500 psig, the fuse metal will cold flow until the silane starts to leak and ignites. This fire will heat and melt the remaining fuse metal. Without the backing of the fuse metal, the rupture disk suddenly opens completely venting the contents of the cylinder in minutes. If this happens when nested with other silane cylinders, the fire will cause the other PRDs to activate.

All of the gas suppliers have experienced at least one event like this during the storage of cylinders. The largest incident of this type involved 215 silane cylinders in 1997 stored outdoors in one nest, all relieved in a period of 3-4 hrs.

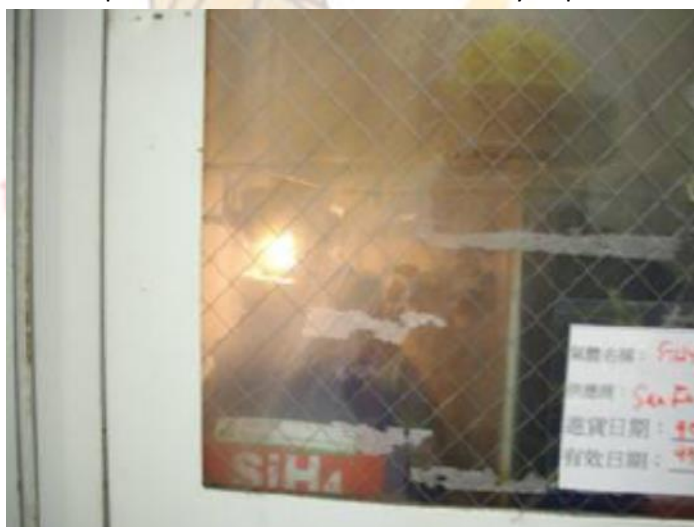
b. Use of Elastomer Gaskets

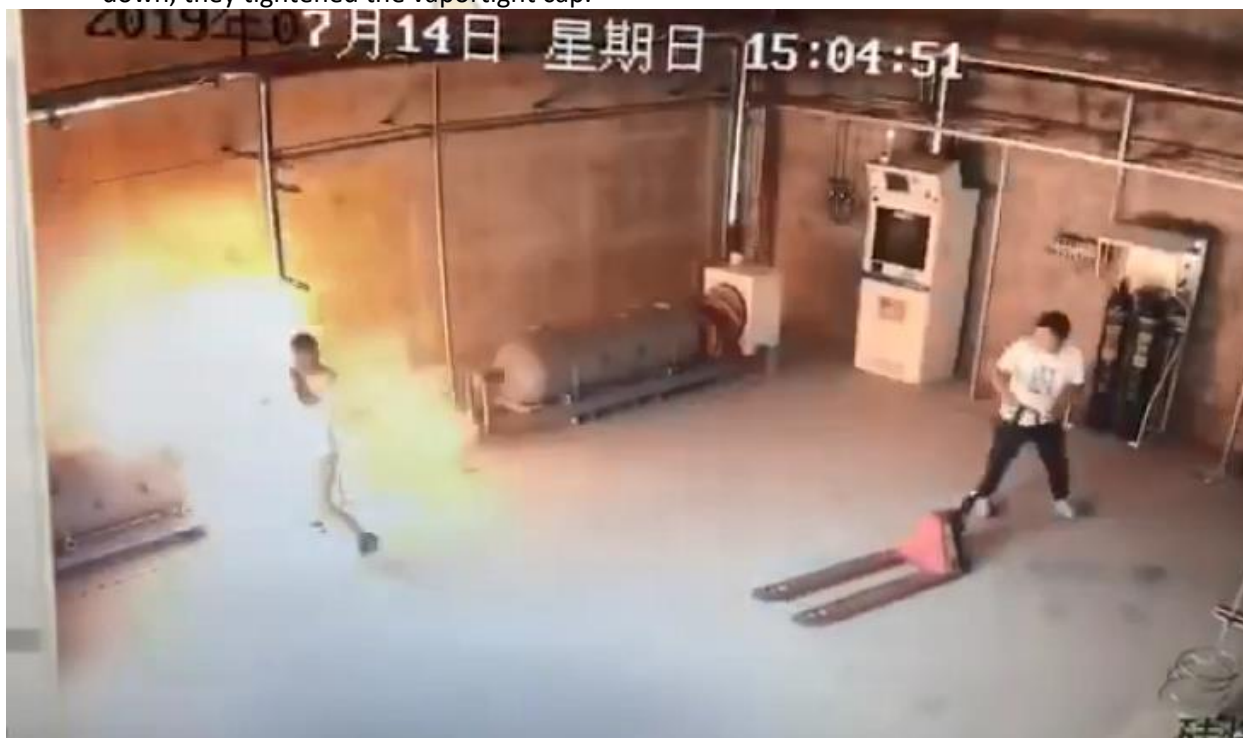
3. Operator Error

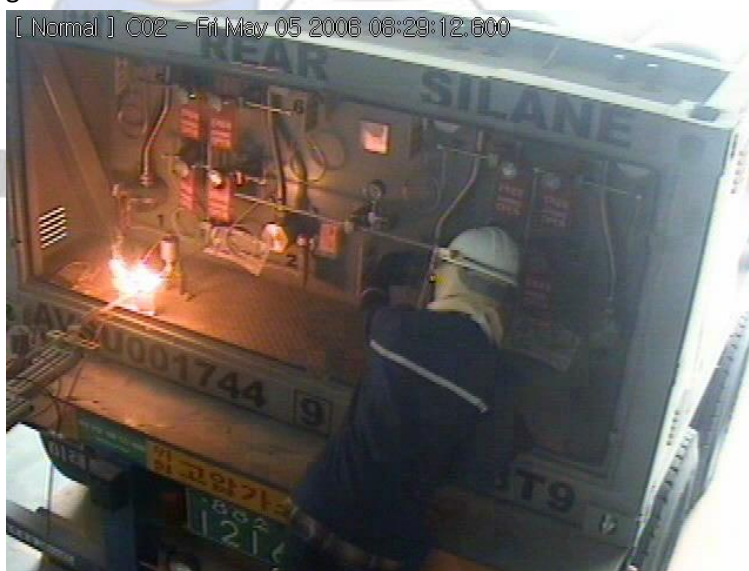
Expansion of high pressure silane liquefies a portion of the silane. This can cause thermal contraction or embrittlement of system components. Leaks and system failures have occurred with improperly designed systems. Regulators which are typically where the expansion occurs have had diaphragm failures due to cold temperature embrittlement of the sealing gasket. During system startup of a 1,000 meter supply line, the flowrate into the line which was under a vacuum was extremely high, the expansion cooling through the RFO caused the connection to leak.

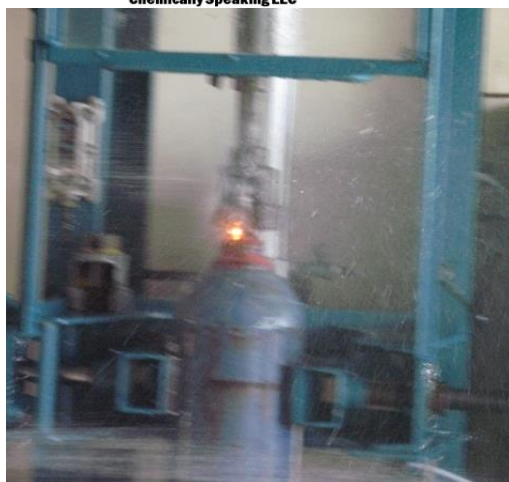
15. Unbelievable Category

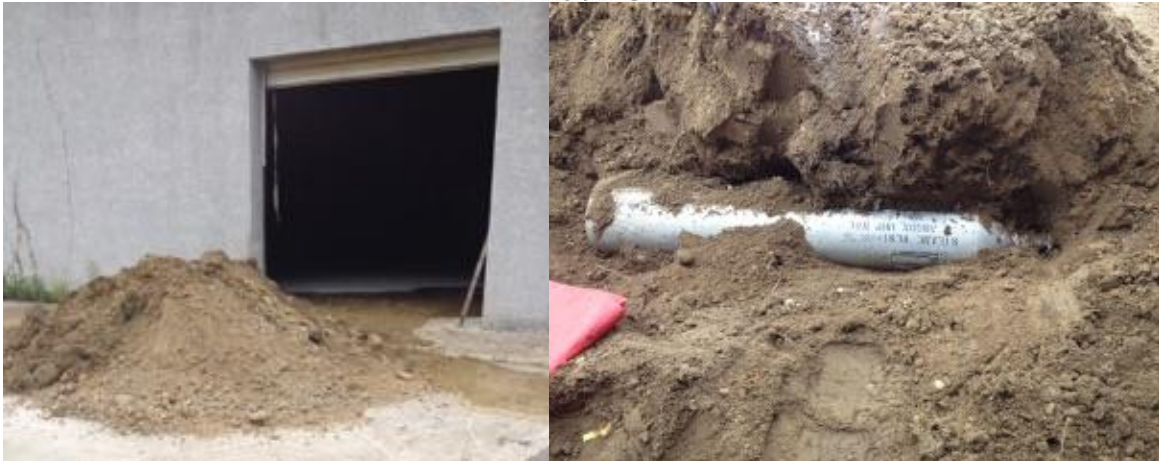
A silane distributor operated his business out of a motel in the 1970's. At least 3 major US Semiconductor Companies knew they were shipping to a Motel! In 1998 when the Motel was being demolished, they found 18 full cylinders in a basement storage room. The Fire Marshal gave these to a local hydrotest company who was going to simply open the valves and vent them!
