Chlorine Trifluoride

Aug 2021

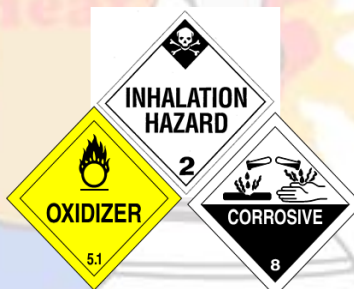
Chlorine Trifluoride (ClF_3) is a low pressure liquefied gas that is toxic, corrosive and a strong oxidizer. The vapor is colorless while the liquid is a pale yellow/brown.

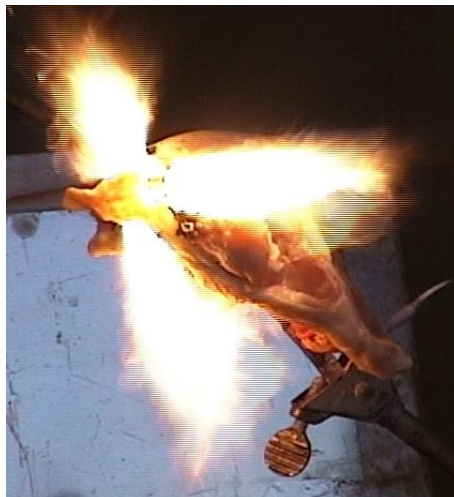
Reaction with oils is violent. Vapor reaction with raw chicken skin is intense. Liquid is explosive.

Fig. 3: ClF_3 Vapor and Raw Chicken
