Asiafreighter Arsine Incident

June 2021

Chemically Speaking LLC
Eugene Ngai

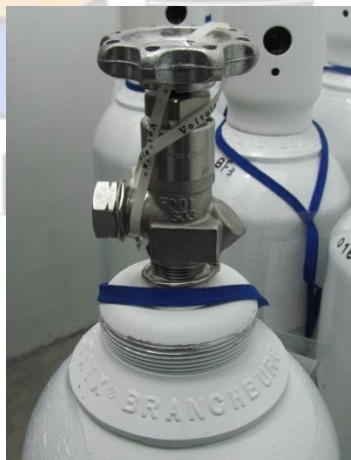
Fig. 2: Cylinder Valve Wire Tied

As a Best Practice companies started wire tying the valve handle shut for shipment to prevent it from vibrating open. Plastic shrink wrap around the valve provides additional physical securement of the handle.

1. During rough handle or transportation, cylinder valves could torque open. This was not the only incident in which this has happened.

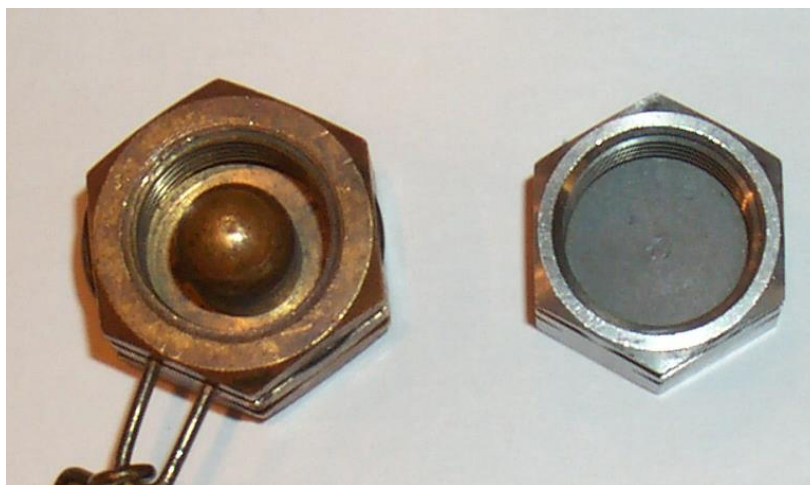
Fig. 3: Vaportight and Dust Caps

2. Dust caps are not designed to be vaportight. The regulations now require a vaportight outlet cap to provide secondary seal for all highly toxic or pyrophoric gas cylinder valves. The nipple in the

center seals against the valve outlet connection while a dust cap may have a fiberboard or PTFE gasket.

Numerous tests were conducted which determined that the cylinder and valves were leakfree and functional. The valves opened during the violent storm (Cyl A) had a dust cap with a damaged seal while the Cyl B dust cap was able to seal even installed only finger tight.
