Y Cylinder is a Robust Package

July 2022

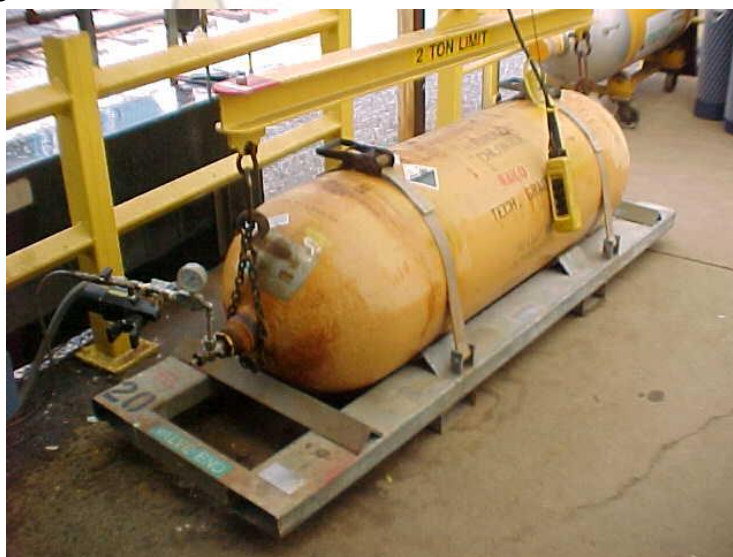
A horizontal carbon steel high pressure seamless cylinder 24" OD. Internal volume that can vary from 15.7 ft³ (444.6 l) to 16.70 ft³ (472.9 l). Nominally 454 liters that is defined as a bulk cylinder by CGA. It holds more than 10 times the volume of the typical 44 liter cylinder.

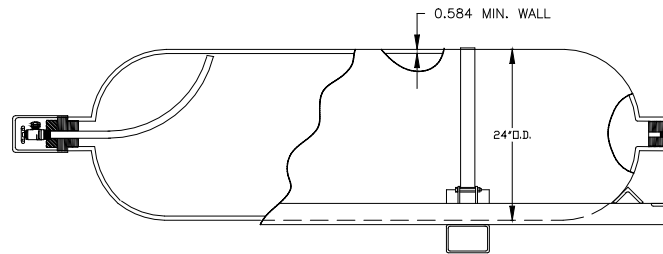
Hydrogen chloride as a liquefied compressed gas, the user must orient the Y Cylinder so that the goose neck tube is positioned upward inside the cylinder for vapor use or downward for liquid use. 40 years ago the Y cylinder was shipped without a cradle. The user had a roller that they placed the Y cylinder onto and could roll it to the right orientation. The valve outlet connection was oriented to the gooseneck position.

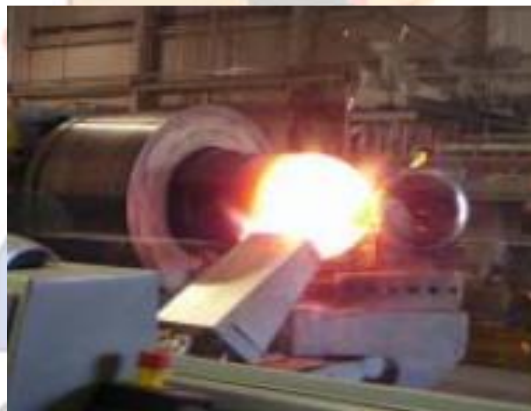
FIBA Fabrication (3AAX)

The ends of the tube are then preheated red hot. As the tube is spun, a robot arm starts to neck the end of the tube to form a concave head with a neck.

After both ends are formed, the tube is heat treated and quenched in a hot oil bath. Each end is then machined with a CNC to face and thread the neck.

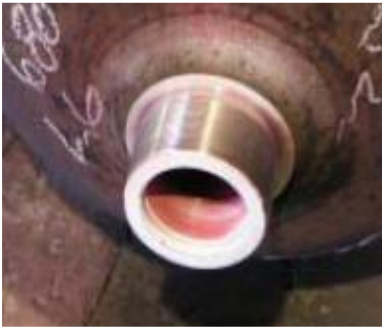
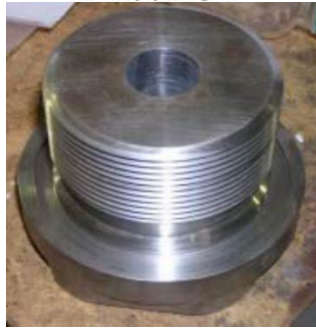
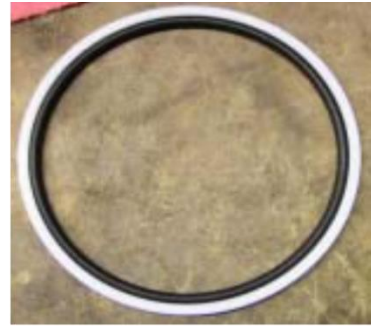
Each end is machined to 3 ¼" threaded opening which is plugged with a threaded Bullplug, sealed with a Viton O Ring and Teflon Backing Ring. Surface finish of the bull plug and tube are critical for a good seal, the bull plug is torqued onto the end until the metal surfaces mate (800-1,000 ft-lbs).

Most common configuration is a cylinder valve and PRD on one end and a PRD on the other. With PRD's becoming optional for many gases, the bullplugs are blank on one end. Some Y cylinders have a valve on both ends to allow the user to select liquid or vapor. The cylinder valves are protected by a metal cap.

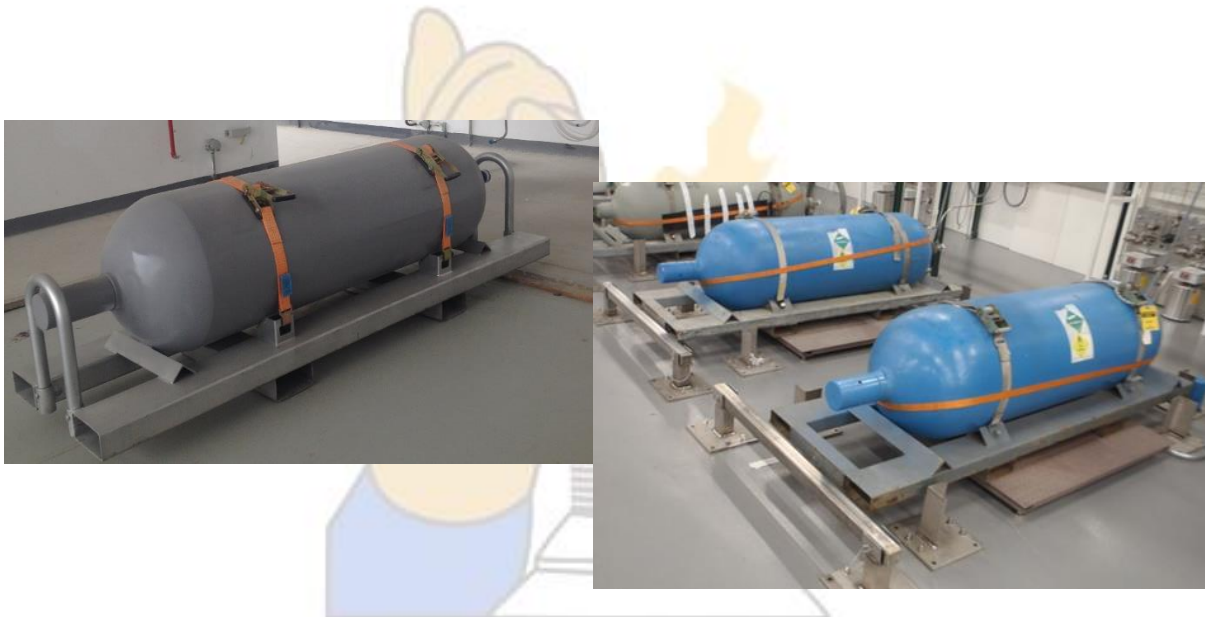
This is a very robust package. A steel rollbar on the skid protects the cylinder valves from physical impact damage during transportation and handling. Testing in 2004 by Air Products, demonstrated that a Y container dropped during handling will not damage the valve. The metal skid prevents the cylinder cap from being impacted when it is dropped.

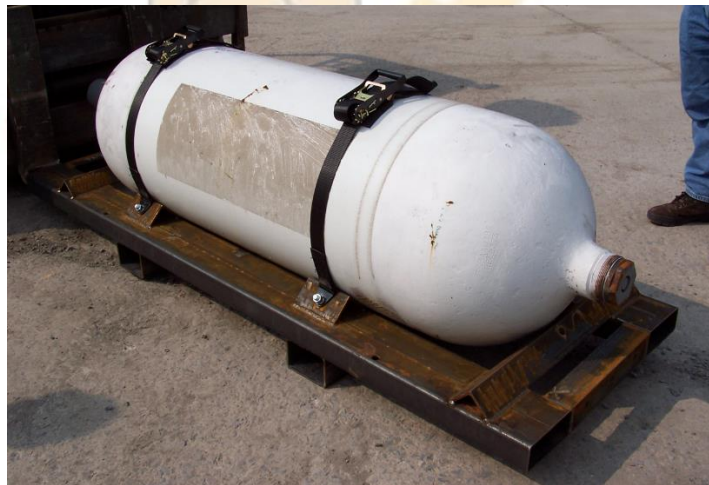
Test Y Cylinder

Manufactured by CPI

Manual Tied Diaphragm 316 ss Ceodux Valve, 640 DISS

Was fill completely with water to 2393 lbs

New skid with straps that were load rated for 2333 lbs and 3300 lbs with a breaking strength of 10,000 lbs

Changed skid after Test #1

New American Cap used. Replaced after test #3, Cap Impact

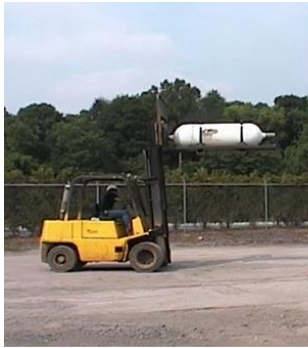
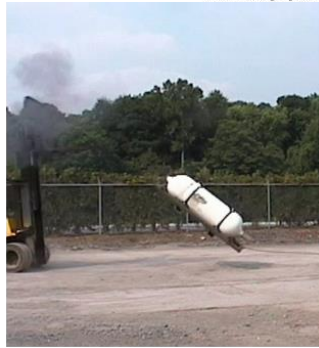
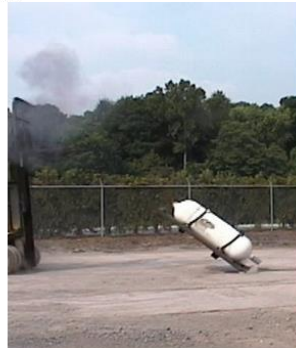
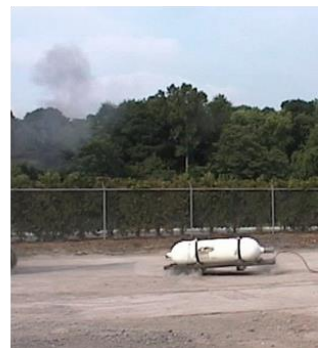
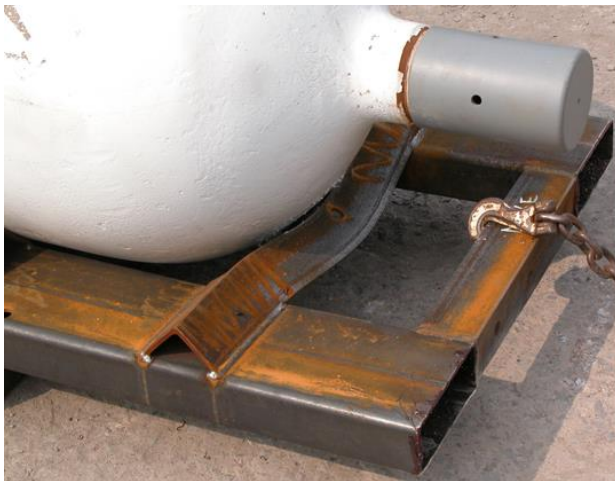
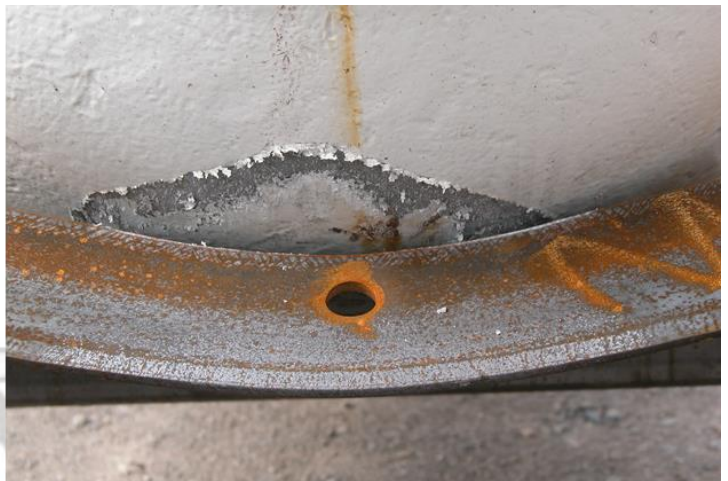
Test #1 Drop Flat Onto Skid

Forks were level

The front of the skid hit at a 45° angle causing minor damage to the front skid

At impact. the Y slid forward and bent the skid front cross angle

It then bounced backward and the Y slid back bending the skid rear cross angle

The skid bounced forward and the Y slid forward again

The front strap loosened slightly

No damage to the Y or straps

No leaks at 100 psig N₂

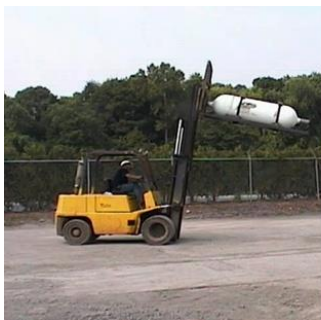
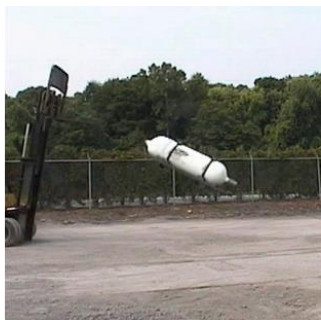
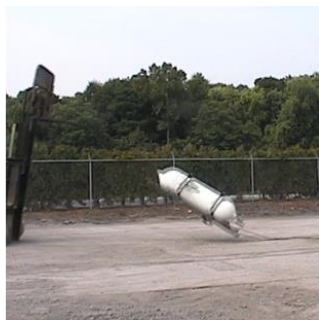
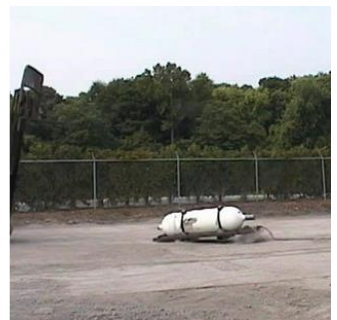
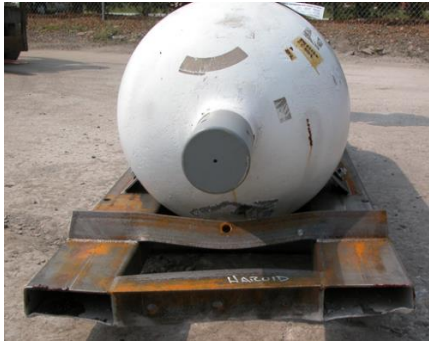
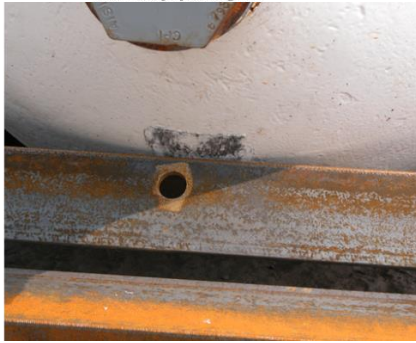
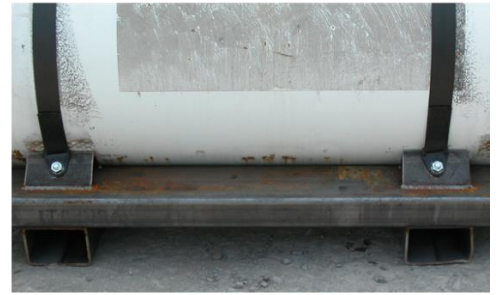
Test #2 Drop at an Angle

The forks were tilted to the maximum (10' rear & 8' front)

Front of skid hit at a 45° angle

Major damage to the front skid upon impact

Y did not slide as much as Test #1

The skid bounced backward and damaged the rear forklift channel

Straps stayed tight

No damage to the Y or straps

Y still had 100 psig N₂, there were no leaks

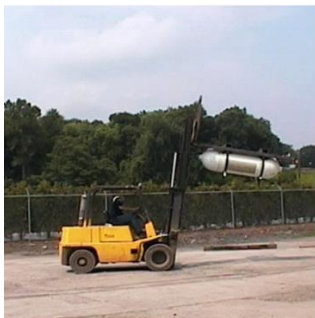
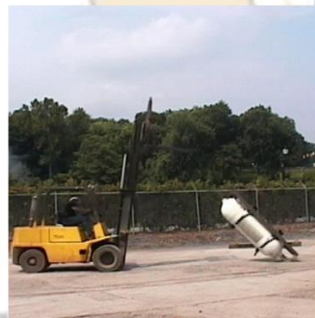
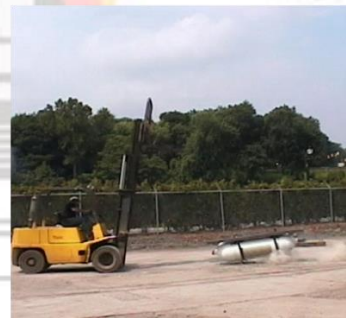
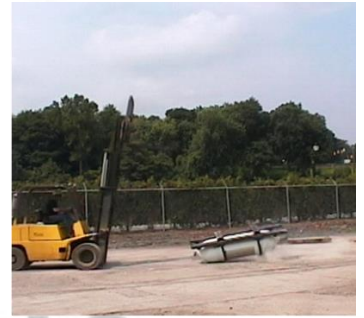
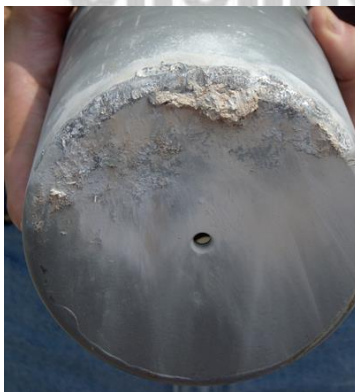
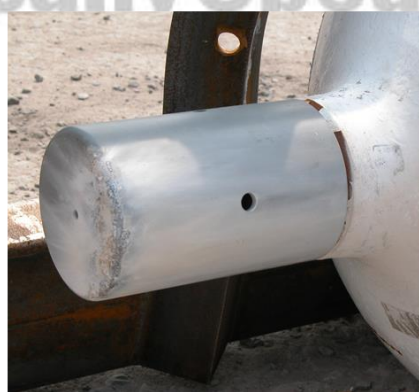
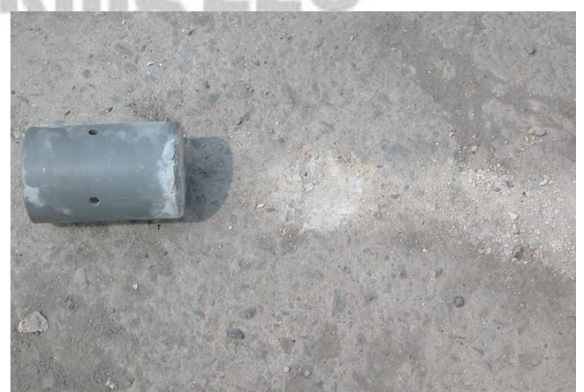
Test #3 Drop Upside Down Onto Cylinder Cap

The Y was hung upside down on the forks so that the impact would be on the cap.

The forks were tilted to the maximum (10' rear & 8 ½ ' front)

Was dropped without using the chain

The Y impacted onto the cylinder cap at a 45° angle

It bounced backward and then forward

Chipped out a hole in the concrete 1" deep and 4" diameter

Only minor damage to the Cap

The cap was easy to remove

Y still had 100 psig N², there were no leaks

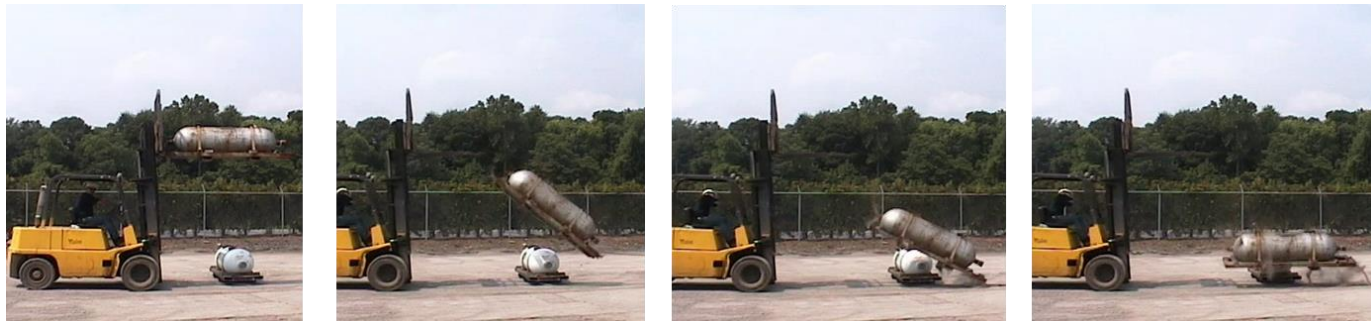
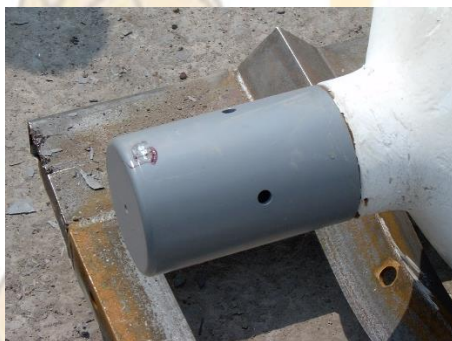
Test #4 Y Onto Y Cap On The Ground

An old empty HCl Y weighing 1325 lbs was dropped onto the Y with a cap on the ground.

Forks were level and the Y was pulled off

Skid front hit the ground first and pivoted backward hitting the cap

The dropped Y bounced on the rear skid and hit the cap again

Minor damage to the cap

Y still had 100 psig N₂, there were no leaks

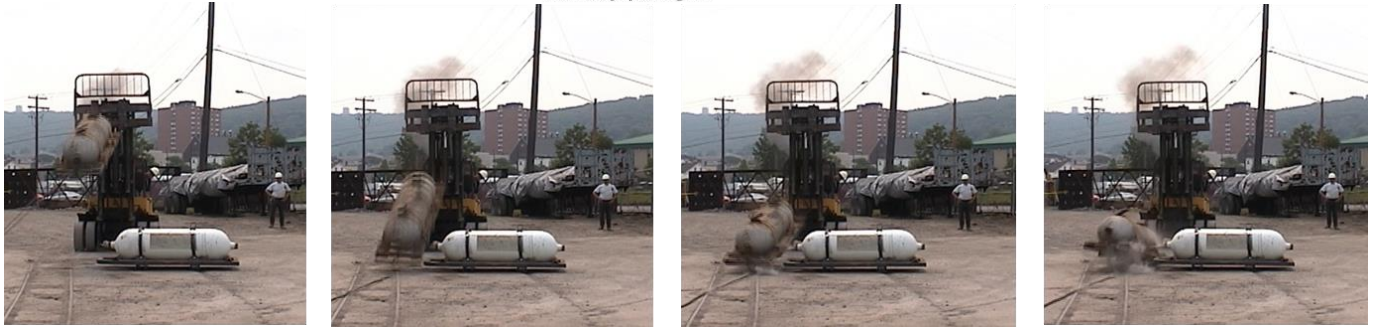
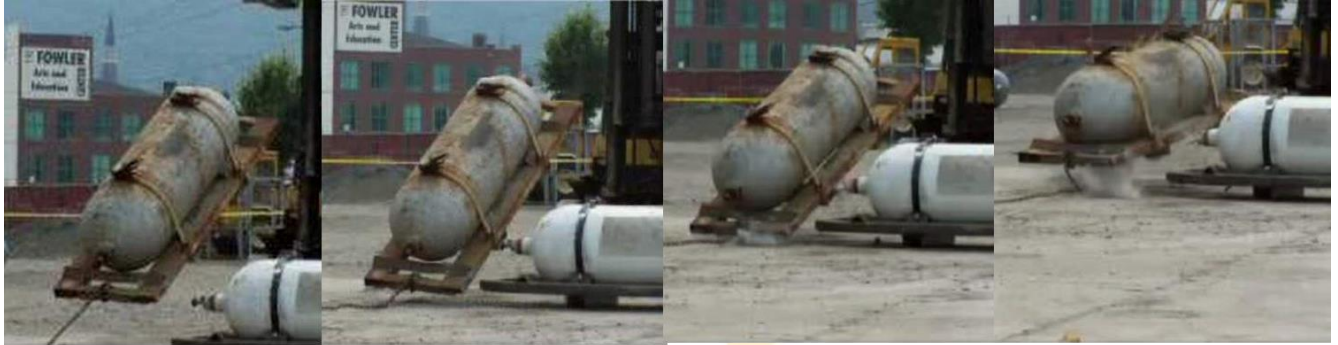
Test #5-1 & 2, Y Onto Valve, No Cylinder Cap

First dropped Y missed the valve by inches

Second dropped Y hit valve handle with skid front forklift channel. This damaged the valve causing a leak.

Impact made a dent in the channel

The front of the dropped skid hit ground after the valve impact

The skid pivoted backward and the center of the skid hit the valve again. It pivoted on the valve and hit the ground on the rear skid

The dropped Y bounced back and hit the valve again which caused the dropped Y to flip over

Y Hits Valve before
 the ground

Y Hits the ground

Y Pivots and Hits
 Valve Again

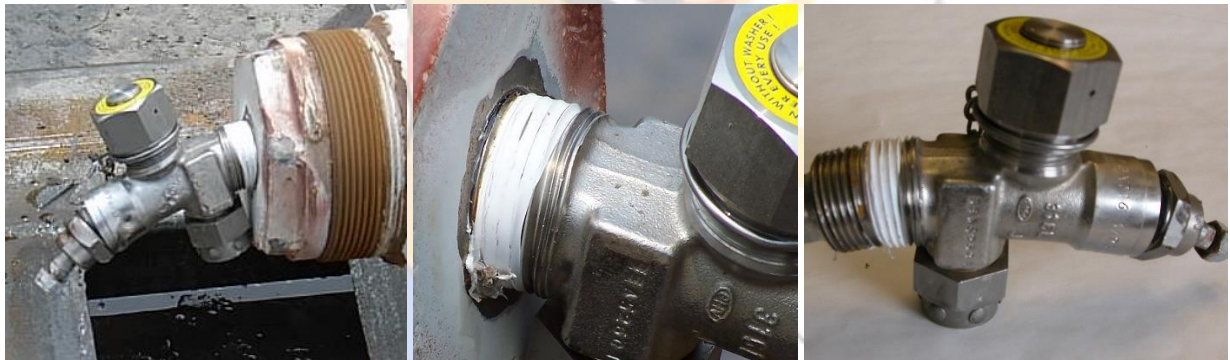
The impact broke off valve handle and hit the top of the valve bending it toward the bullplug. This pulled out the diaphragm nut causing a leak. Since the Y was still pressurized with Nitrogen, the water came out immediately from the leak check port and diaphragm nut
 Valve cracked at the threads but not through to the inner bore
 The PRD stopped the bending, preventing the valve from cracking fully

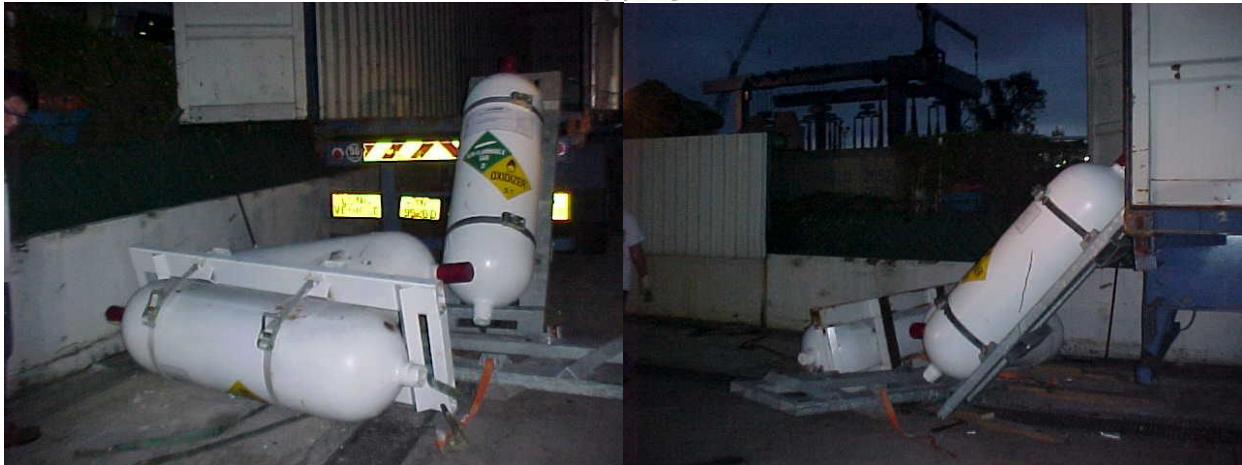
Y Cylinders have been involved in motor vehicle accidents without serious damage or leaks.

A gas supplier forwarded pictures of a NH₃ Y that was in a 40' trailer on a skid. The driver fell asleep and crashed through a guardrail into the side of a canal. The Y crashed through the bulkhead of the trailer through the cab and hit the concrete wall where it ricochets out of the trailer and down the canal embankment. It only suffered minor scratches, no leak.

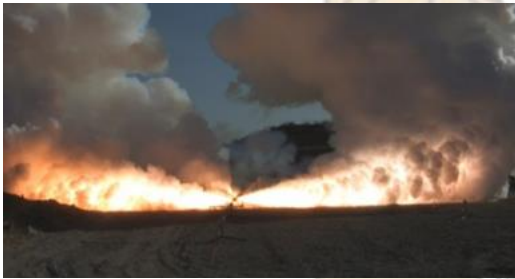
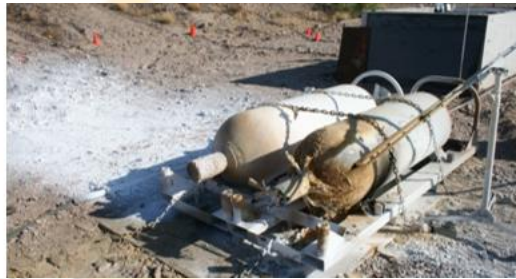
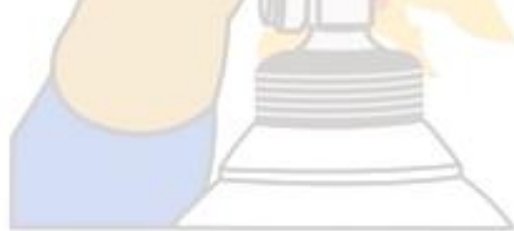
Even in the 2011 testing with full flame impingement from a silane Y PRD did not heat the adjacent Y filled with N₂ hot enough for it to rupture since the time was less than 3 minutes.
